Annual Inspection Report

Oneonta Municipal (Robbins Field) Airport

ANNUAL INSPECTION REPORT

ONEONTA MUNICIPAL (ROBBINS FIELD) AIRPORT
ONEONTA, ALABAMA

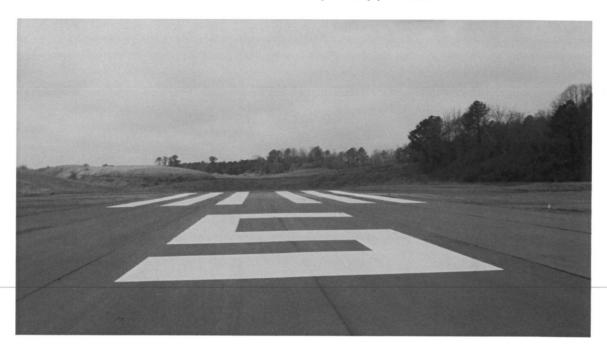
Photo #1 - Runway 05 Approach

- Runway 05: There are no obstructions (See Photo # 1).
- Runway 23: There are no obstructions (See Photo # 2).

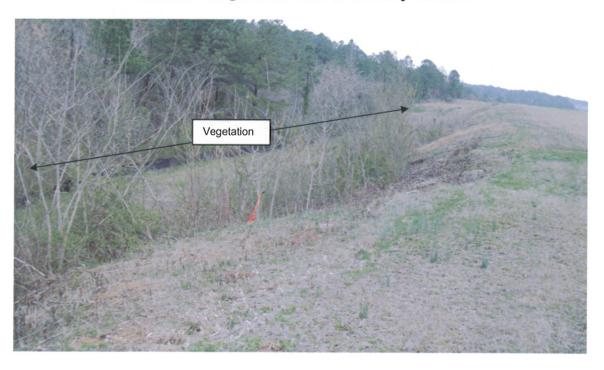
The primary surface was clear with the exception of some overgrown vegetation located in the northwest area of the primary surface within 110 feet of the runway centerline (See Photo # 3). Also, pieces of concrete slabs have been discarded within the primary surface (See Photo # 4).

Photo # 3 Vegetation with-in Primary Surface

The vegetation within the primary surface should be removed and maintained in a mowable condition to preclude the growth of vegetation that could become a safety hazard and discarded concrete slabs must be removed.

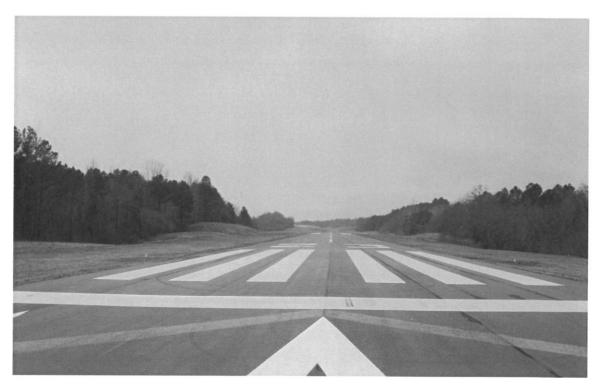
The airport markings were found to be in good condition (Photo # 5).

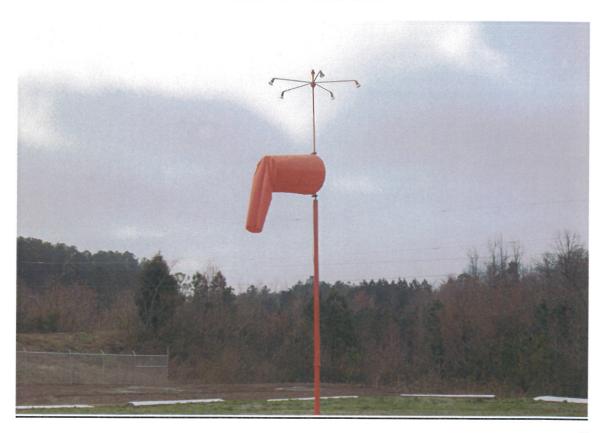
The wind direction indicator was inspected and found operational (Photo #
 6).

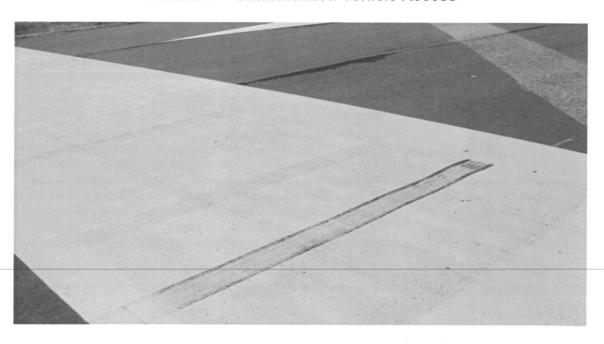
There was evidence of unauthorized vehicle access on the runway surfaces (See Photos # 7 & # 8).

Photo #7 - Unauthorized Vehicle Access

The airport has recently completed a fencing project which should control unauthorized vehicle traffic; however gate access should be controlled along with appropriate signage.

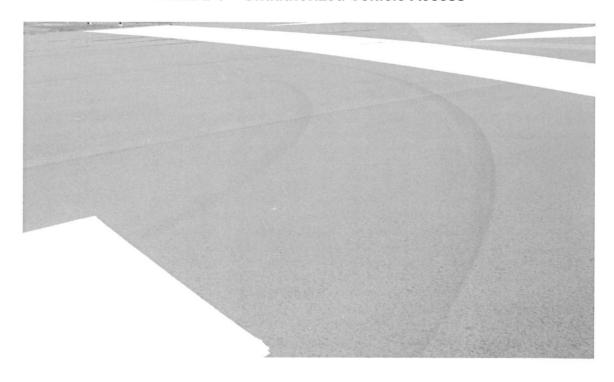
Photo #8 - Unauthorized Vehicle Access
